# Manhole Inspection Summary

Manhole # S41G2\_006MH

Insp Date: **3/28/08 11:40 AM**

**Location** Address: **4344 6th St.**

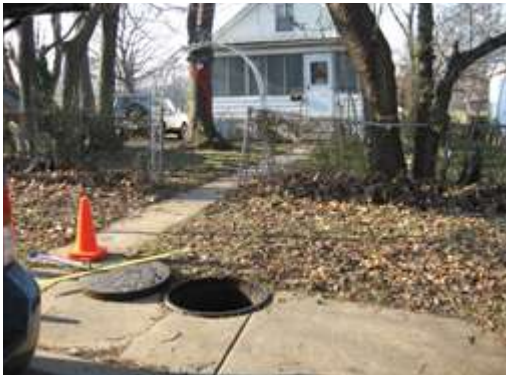
Location View

4344 6th Street

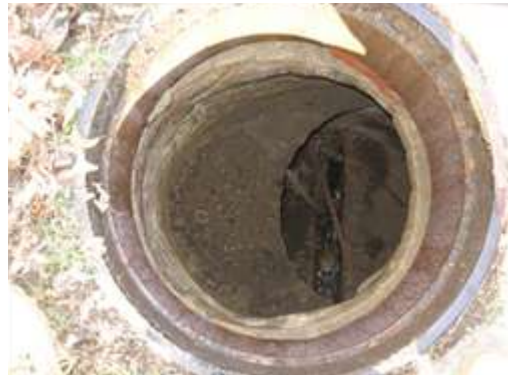
Top View

steps

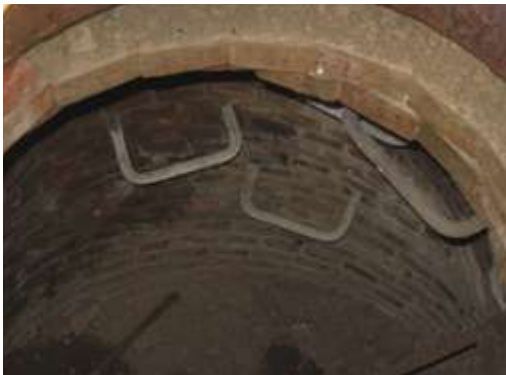
Defect 1

Condition: ☐ Sound ☐ Cracked ☐ Root Intrusion ☐ Loose Brick ☒ **Deteriorated**

Infiltration: ☐ None ☒ **Joint** ☐ Cracks ☒ **Mortar** ☐ Roots ☒ **Wall**

loose bricks on chimney

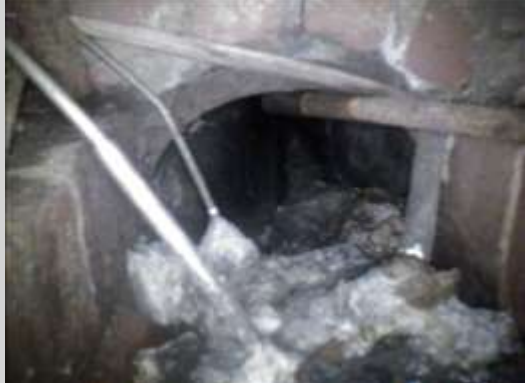
12 O'Clock Outflow

8 in. Circular Gravity Sewer  
Pipe Out @ 12 O'Clock

Pipe Height: **10.8** (in.) Rod and Bar (Angled)  
Pipe Material: **Clay** ☐ Pipe Lined  
Invert Depth: **9.82** (ft.) Flow Characteristics: **None**  
Deposits: ☐ None ☐ Mud ☐ Sludge ☒ **Debris** ☐ Grease  
Silt Depth: **1** (in.) Deposits Extent: **Medium**  
Infiltration: **None** Pipe Seal Cond: **Sound**

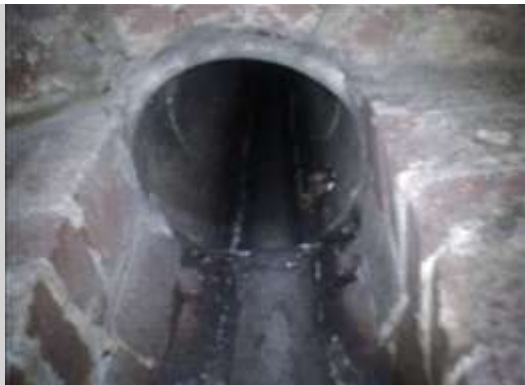
6 O'Clock Inflow

8 in. Circular Gravity Sewer  
Pipe In @ 6 O'Clock

Pipe Height: **10.8** (in.) Rod and Bar (Angled)  
Pipe Material: **Clay** ☐ Pipe Lined  
Invert Depth: **9.26** (ft.) Flow Characteristics: **None**  
Deposits: ☒ **None** ☐ Mud ☐ Sludge ☐ Debris ☐ Grease  
Silt Depth: (in.) Deposits Extent:  
Infiltration: **None** Pipe Seal Cond: **Sound**
